# Romanian Wooden Churches Wall Painting Biodeterioration

## **Abstract**

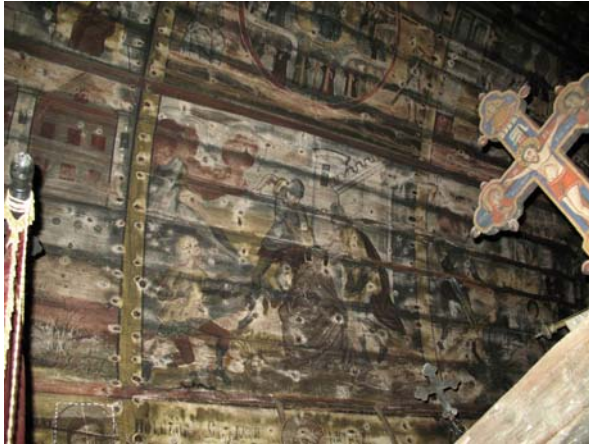
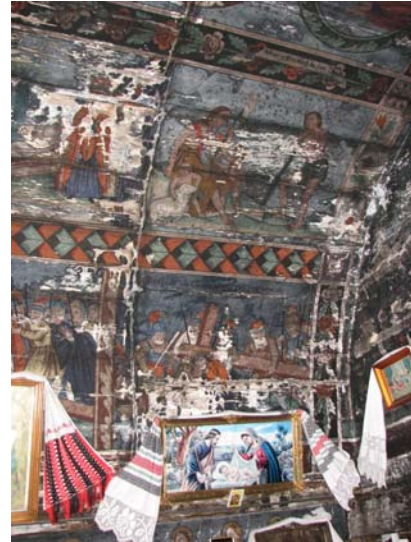
Figure 2 and 3 - Painted ceilings

The inside decoration with these churches was based on the tempera painting technique, taken over from the Byzantine space and perpetuated up to the present day. The painted scenes entirely cover the walls, the vaults and the ceilings of the narthex, nave and altar (figure 2 and 3).

The support of the painting, at the wall level, is made of the surfaces of the wooden beams, between which strips of interstitial canvas was stuck with animal or vegetal glues.

The vaults can be made of beams or planks, between which the strips of canvas were applied.

Calcium carbonate and glue were used to make the start of preparation. The pigments, based on mineral oxydes, were applied over the ground colour by means of organic binders, especially egg.

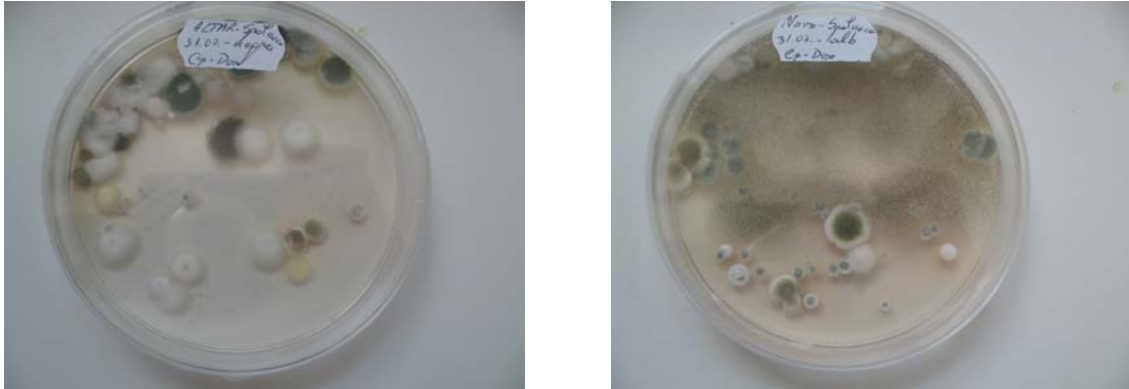
Figure 4 and 5 – Micromycetes identified in laboratory, out of the drawn samples

There were quite rare cases in which I came across the period during which the microfungi produce colonies that are visible without effort. An eloquent example in this respect is the Wooden Church of Spălnaca/county of Alba, where white colonies, having a diameter of 20 to 50mm developed abundantly on the painting at the level of interstitial canvas. (picture no. )

With laboratory colonies, out of the drawn samples, four species of micromicetes have been identified, belonging to *Mucor*, *Penicillium*, *Aspergillus* etc.(figure nr.4 and 5).

The restriction of the decay to the canvas only indicates the preference of these species for the glue used to stick them.

The cause of the massive decay is the infiltrations of rain waters through the degraded wrapping, which led to the rapid growth of the humidity of the support.

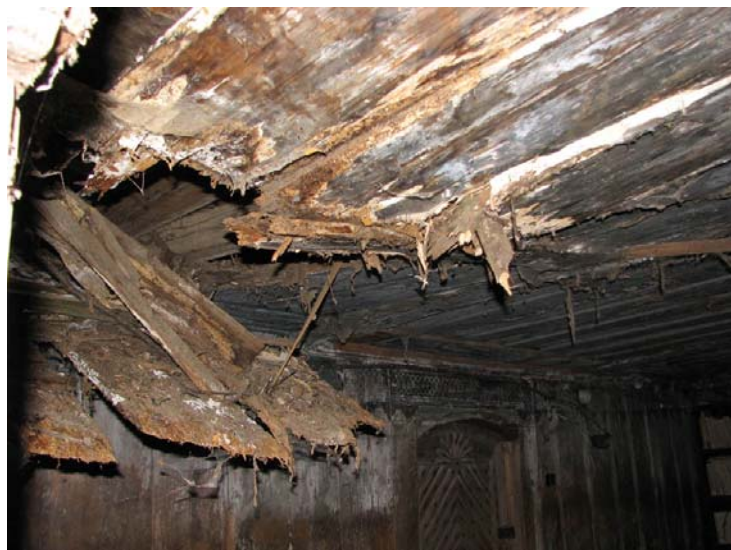
Figure 6 -Vault decayed by the *Coniophora puteana* and other fungi

*Coniophora puteana* has the highest occurrence both on resin wood and on sapwood on the studied monuments [2]. The fruiting bodies are spread on the surface of the painting, attached tightly and are especially frequent with vaults. The decayed wood is degraded in its depth, under the form of prismatic brownrot (figure nr.6).

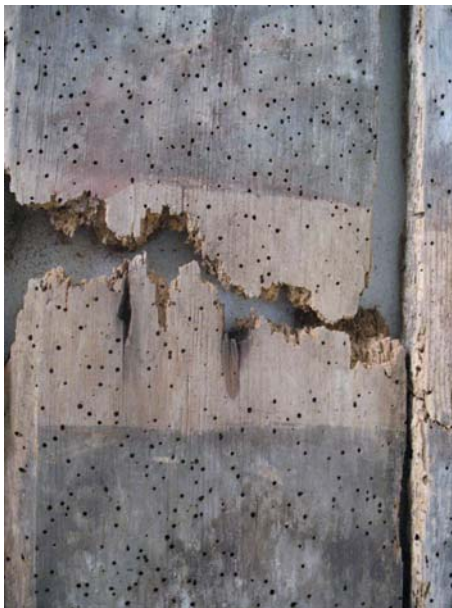
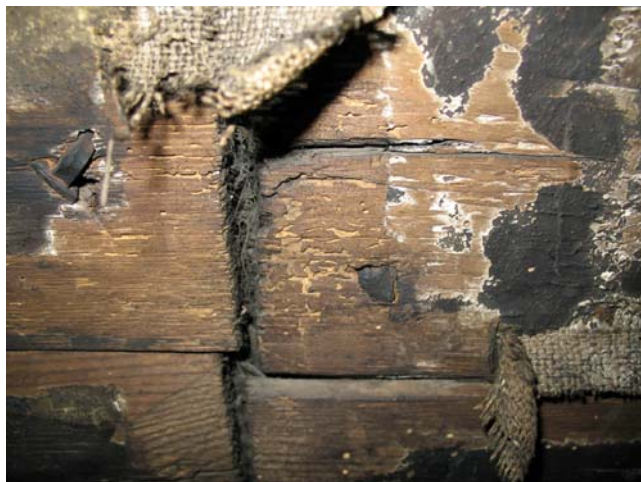
Figure 7 *Anobium punctatum* attacks: (a) areas with infiltrations; (b) under interstitial canvases

It is common knowledge that the attacks of *Anobium punctatum* are more intense on the peripheral areas of the wood, but we can often notice them under the interstitial canvases that were glued or in areas with infiltrations that brought organic substances (figure nr.7).

With higher intensity attacks (which we appreciate by the number of holes of flight per 100 cm<sup>2</sup>), the wood becomes fragile, brittle or breakable.

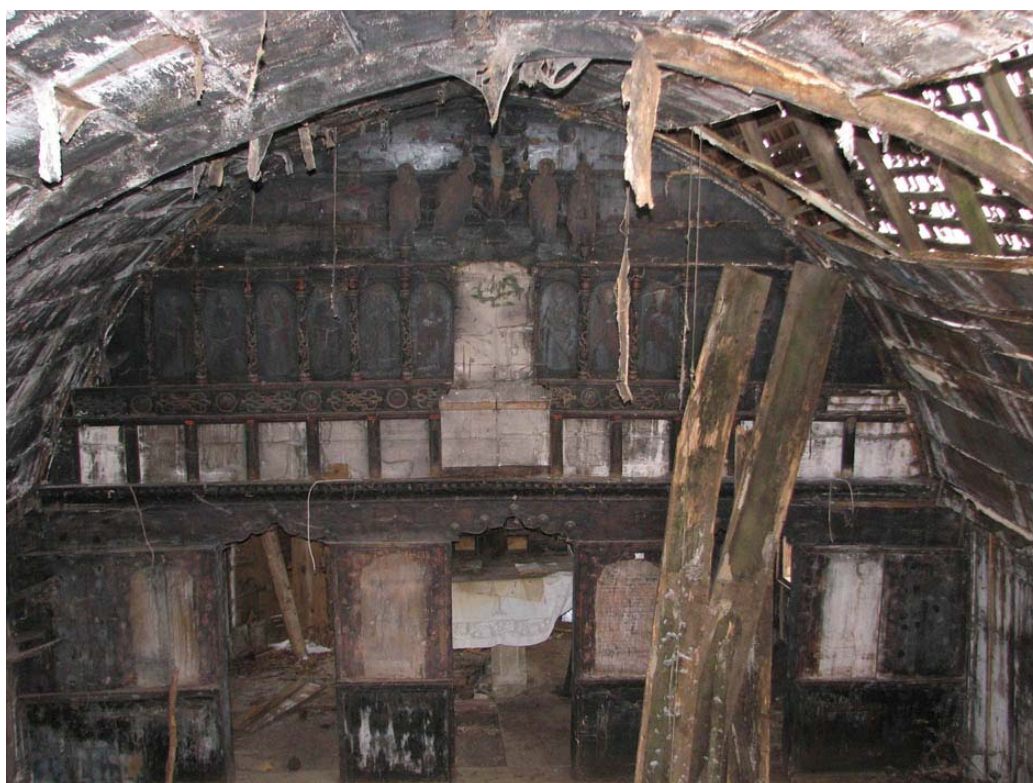
Figure 8 – Vault in collapses

In the case of wooden churches, the parts of the building most vulnerable to biodegradation are the ceilings and the vaults. By their position, they are directly exposed to infiltrations of rain waters, the moment when the wrappings are degraded. The upper part of the vaults, the beams at their basis and the arches sustaining them are the components where water from infiltrations can stagnate. At these levels, the first fungi attacks occur and decays progress rapidly. The arches and the planks come off or break, the beams subside and the vault collapses (figure nr.8)
